Assessing Earth observation techniques for water quality monitoring in Lake Nicaragua

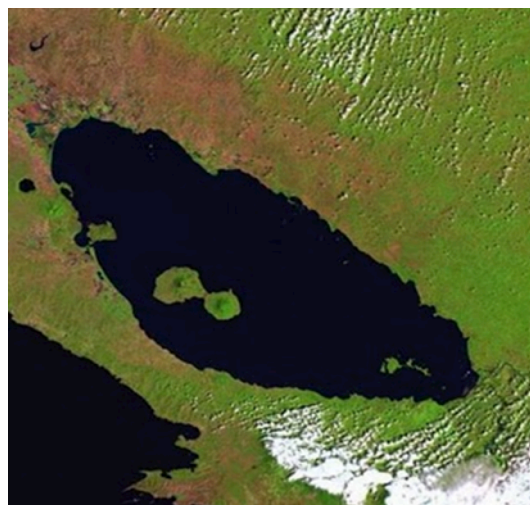
Landsat image of Lake Nicaragua. Note the two prominent volcanos located in the west central part of lake.

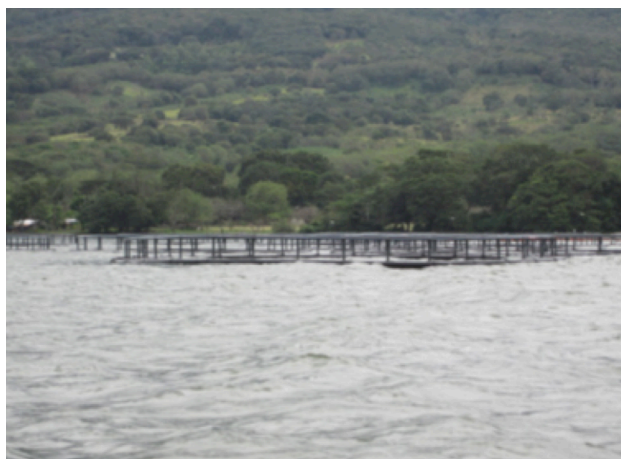
Large Tilapia aquaculture cages in Lake Nicaragua.

duction of new Tilapia fish species inside floating cages in the lake. The problem arises from the large waste quantities generated by the aquaculture that has to be assimilated by the lake. Biologists also warn that the Tilapia might bring diseases to the endemic fish population.
